DEPARTMENT OF NATURAL RESOURCES

Division of Oil, Gas and Mining

Inspection Report Minerals Regulatory Program April 21, 2010

Mine Name: White Cloud	Permit Number: S/015/0044
Operator Name: Sutherland Brothers, Inc.	Inspection Date: 03/25/2010
Inspector(s): Brett Gregory for Wayne Western <i>WFW</i>	Time: 2:00 pm
Other Participants: None	Mine Status: Inactive

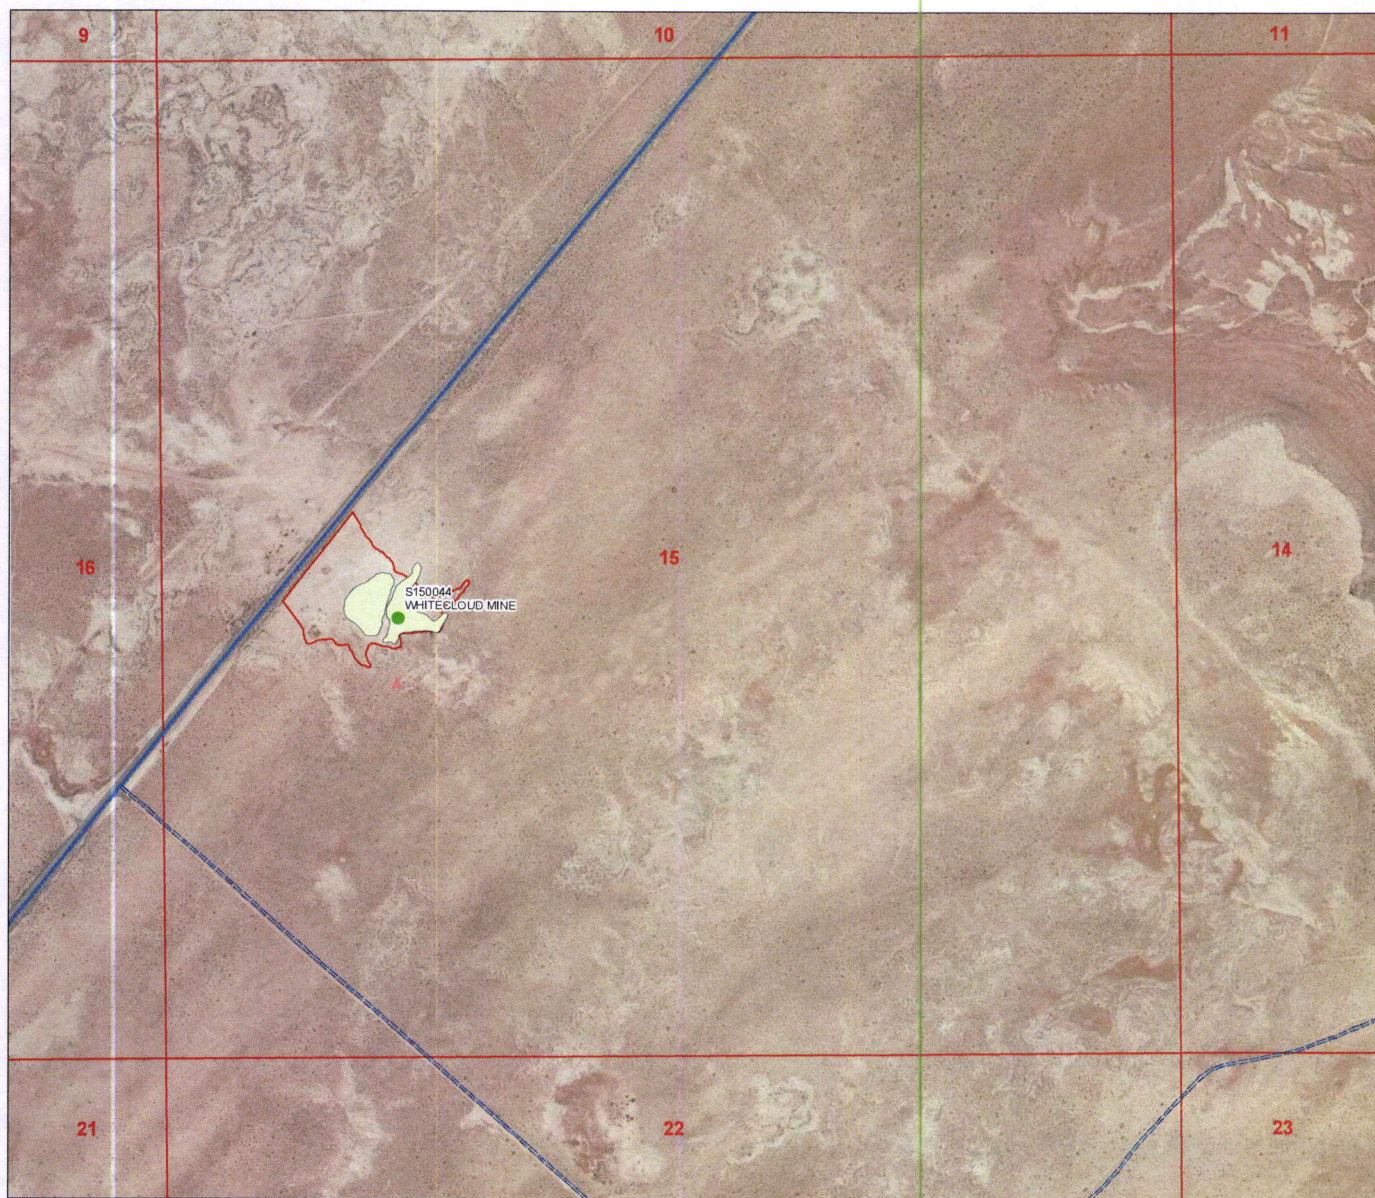
Mine Number: S0150044
Mine Name: Whitecloud Mine
Township 24 S Range 13 E Section 13 SLBM

Acres Disturbed	7.99
Acres Regraded	0
Acres Seeded	0
Road Acres Disturbed	0

Total Acres Disturbed 7.99
